# BUREAU OF SHIPS GROUP TECHNICAL INSPECTION REPORT

⑥ OPERATION CROSSROADS.  
U.S.S. DAWSON (APA79)

TEST ABLE (U).

OPERATION CROSSROADS

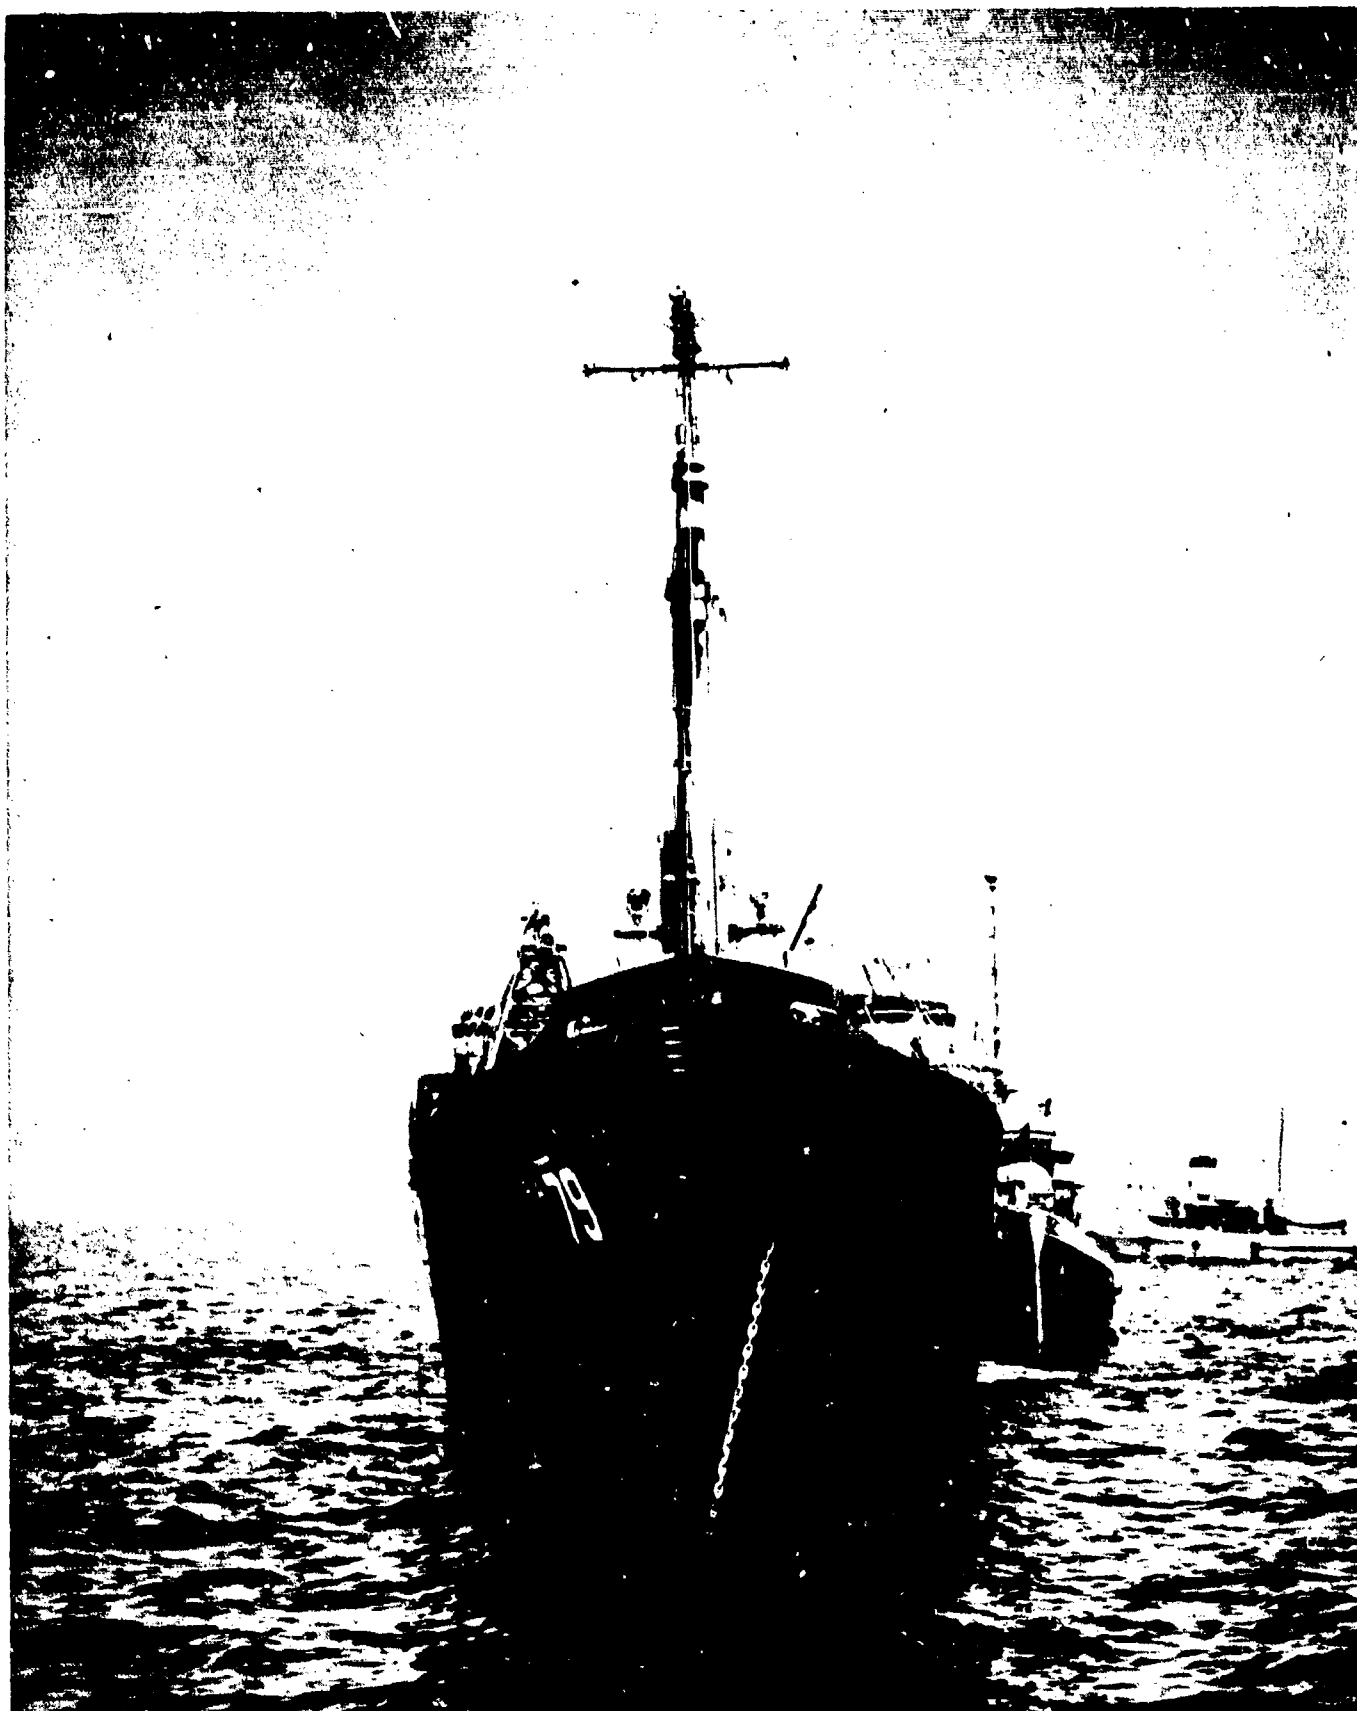
AA-CR-227-87-63. View from dead ahead after Test A.

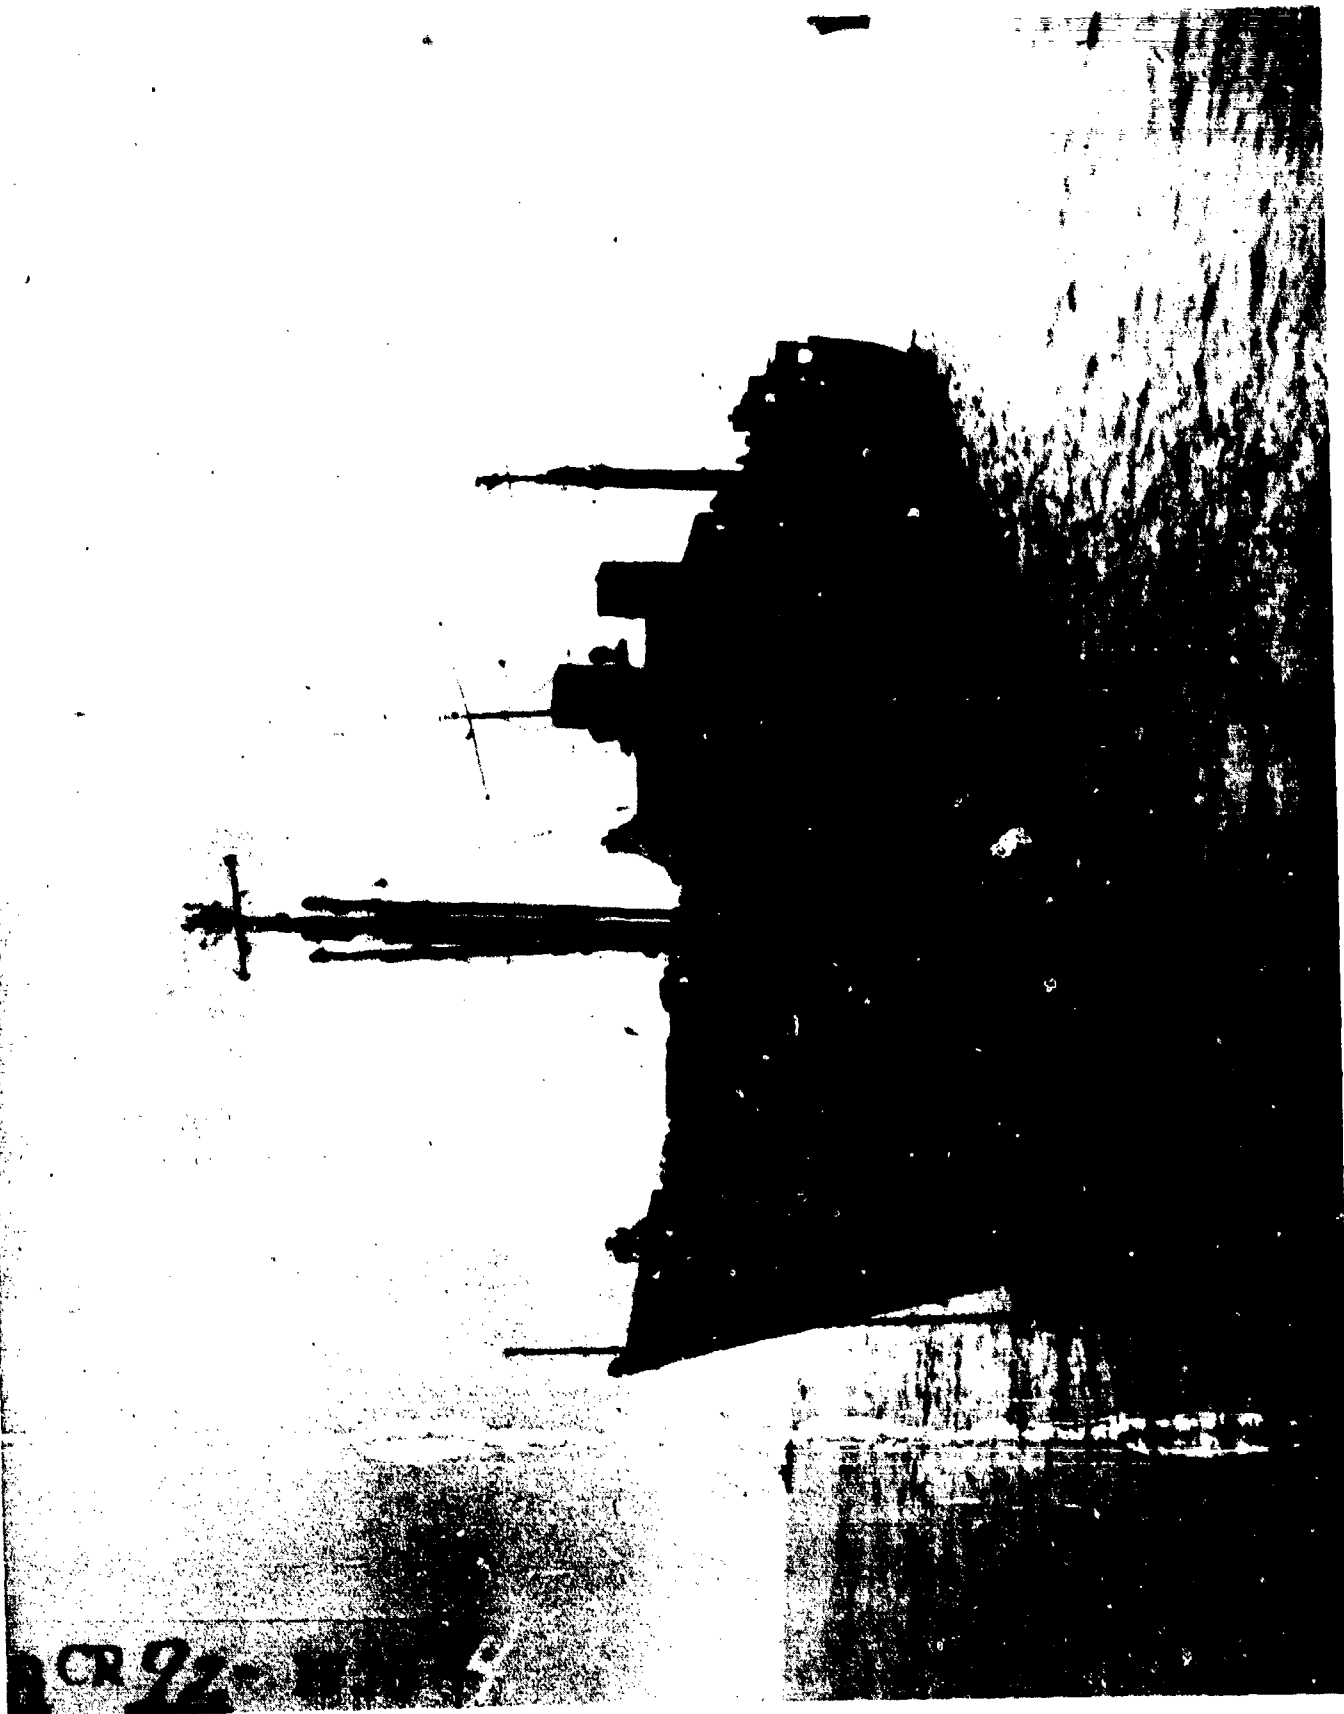
AA-CR-92-1773-4. View from off port bow after Test A.

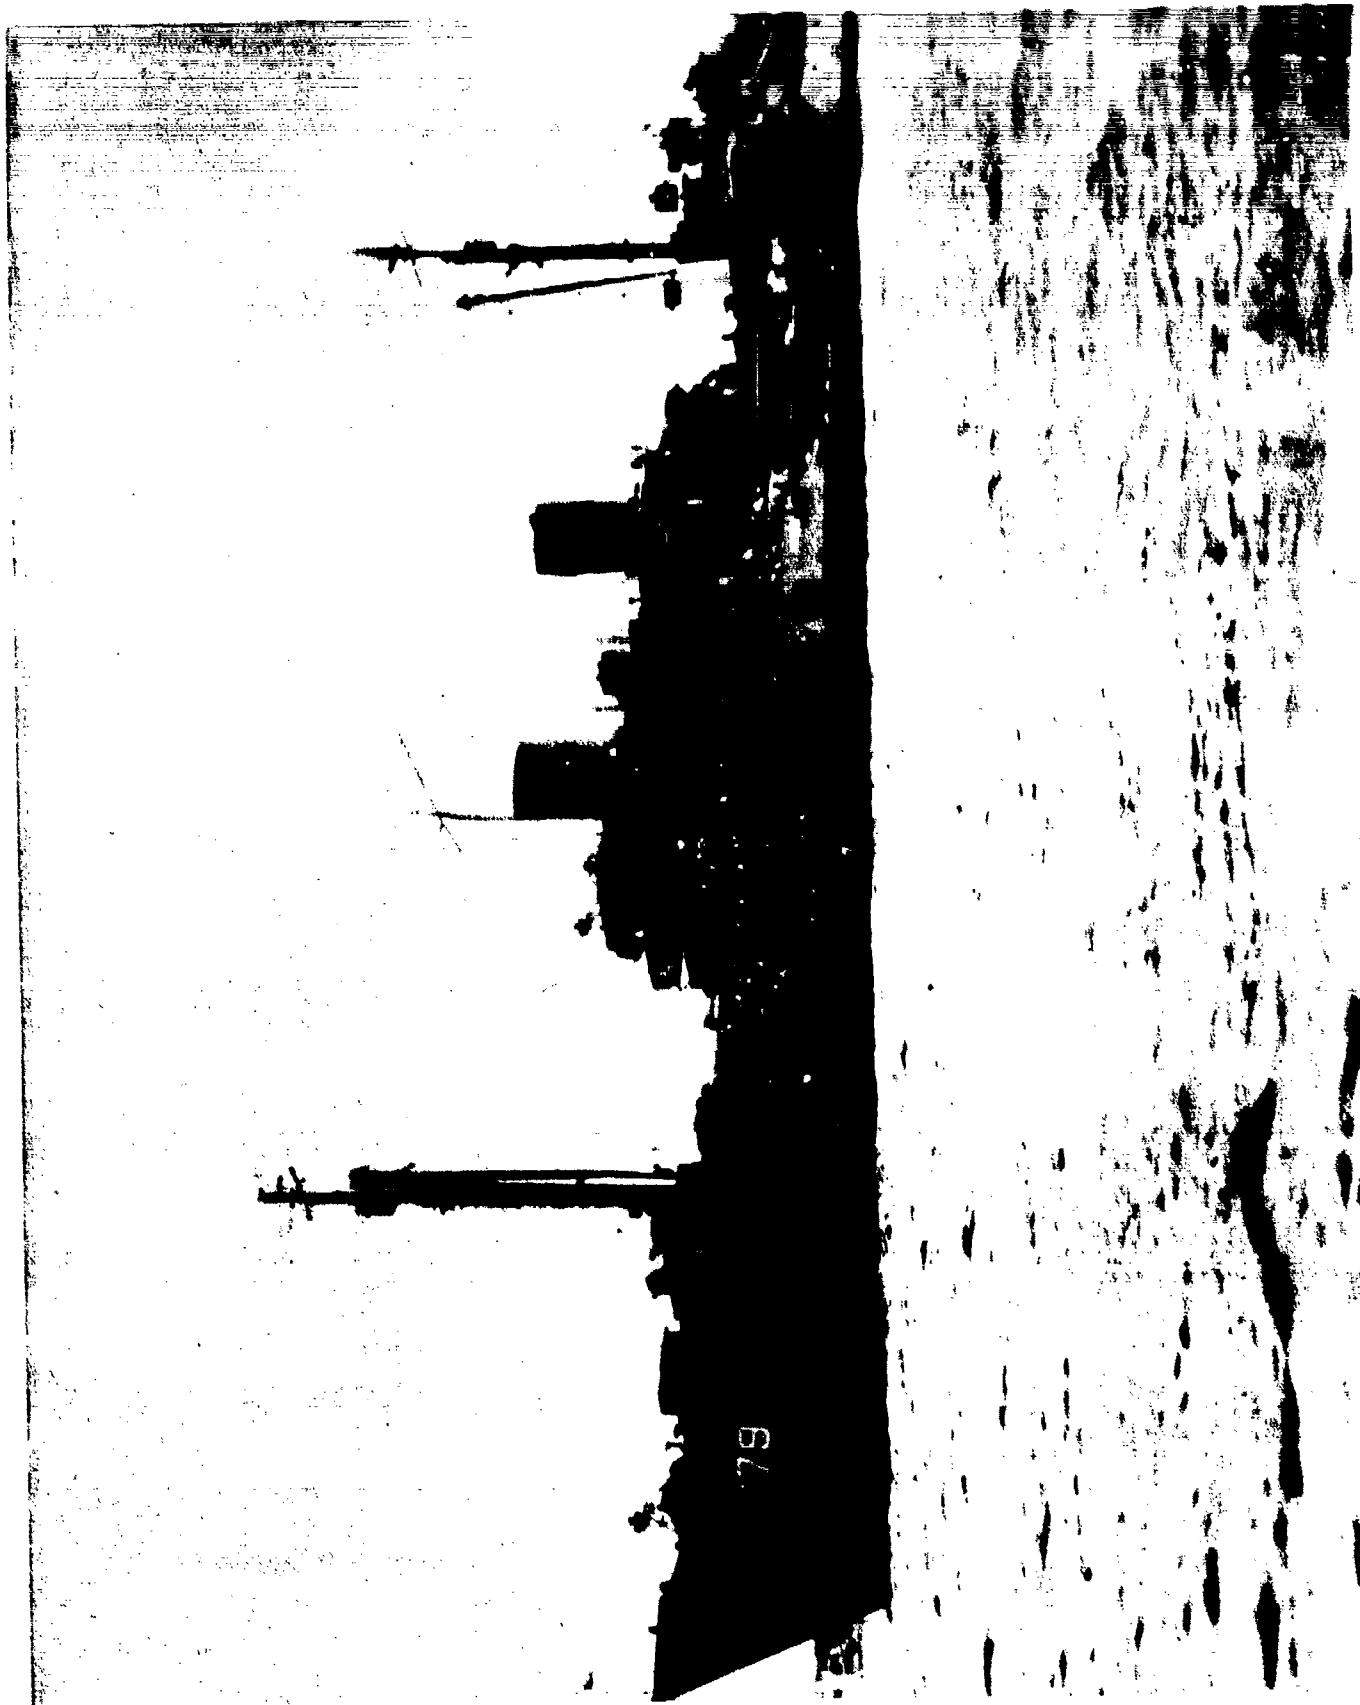
AA-CR-227-92-102. View from off port beam after Test A.

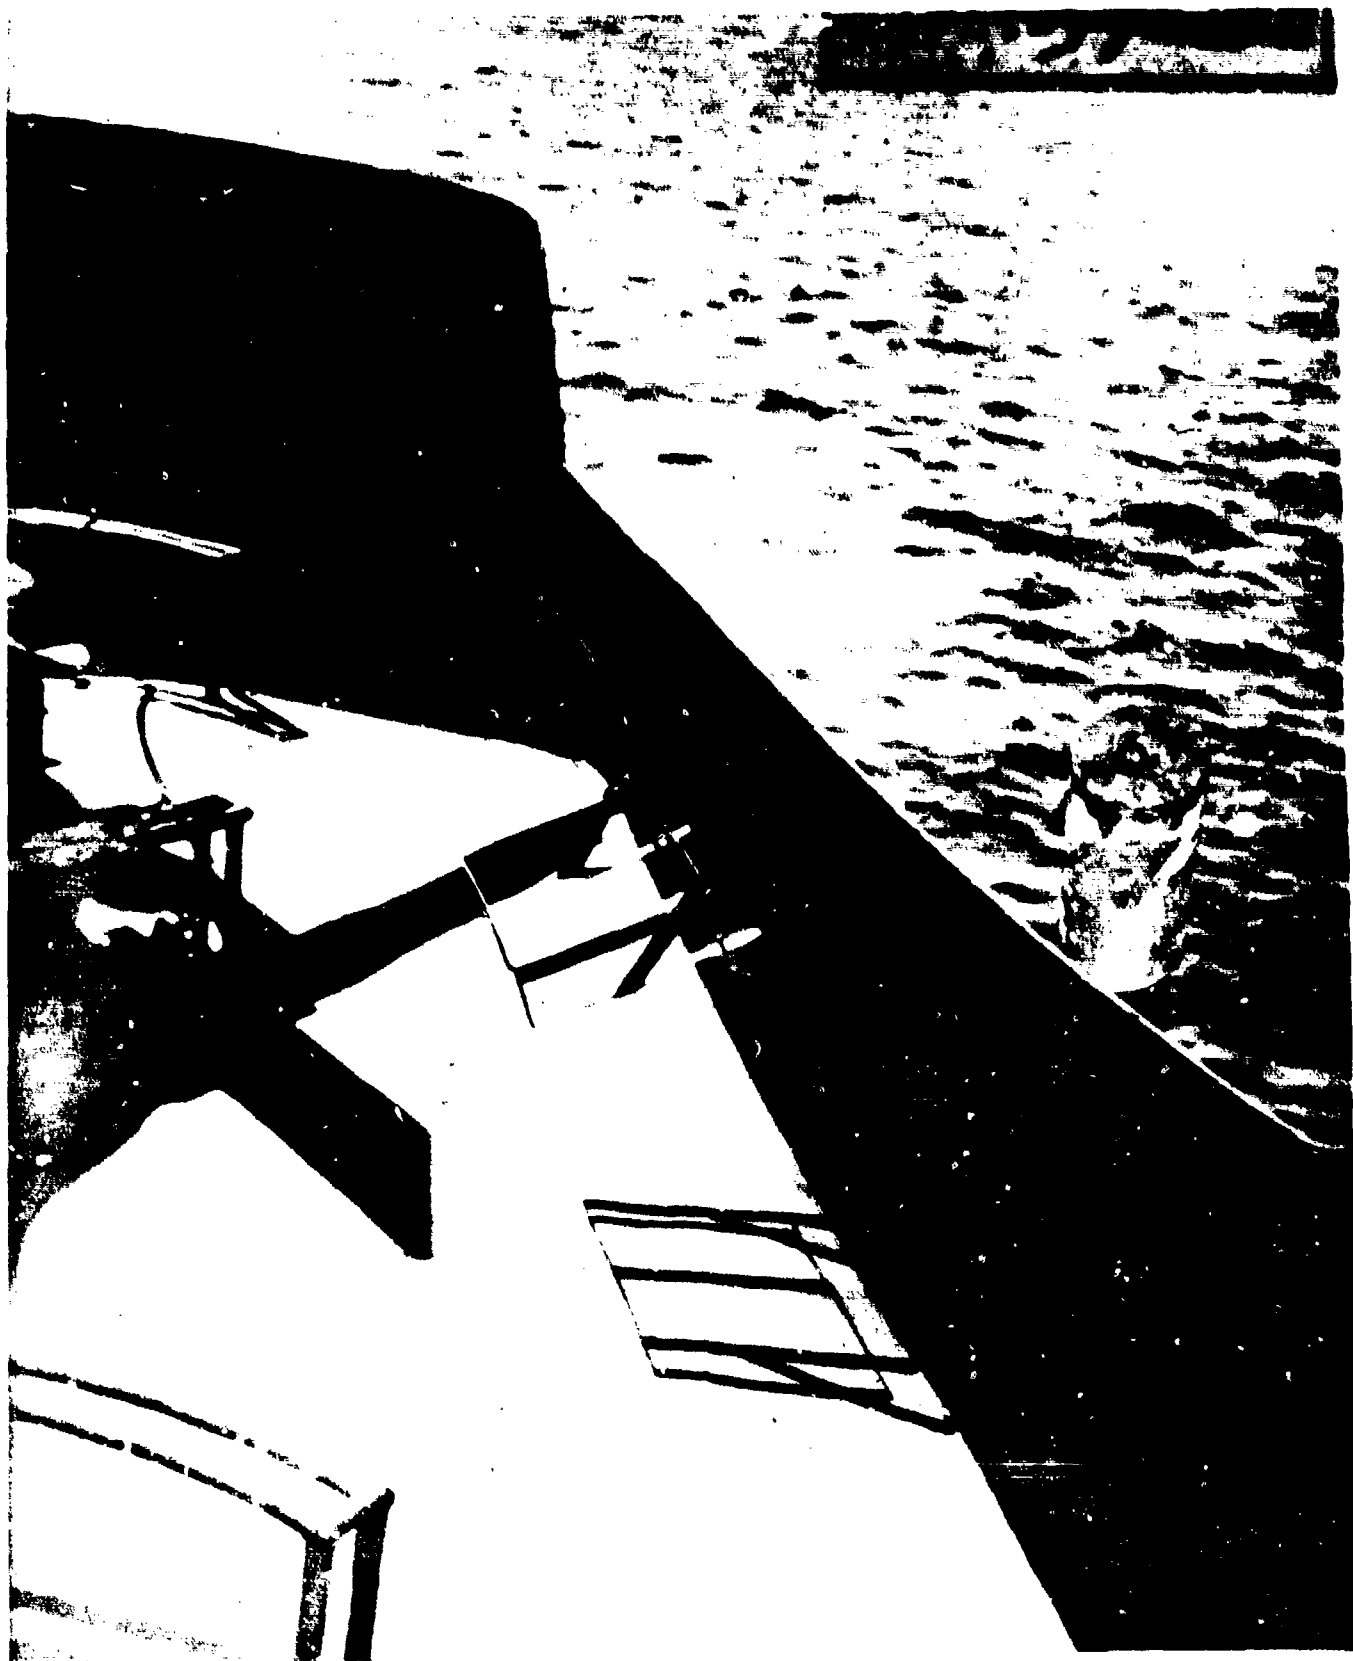
failure in the bulwark capping at the centerline. (Photo. 1741-7; page 78 ). The forward port bulwark of the port 20 MM gun enclosure is deflected approximately 14 inches (Photo. 1741-5; page 75 ).

AA-CR-65-1741-5. Looking to port, along forward bulwark of signal bridge and 20MM gun enclosure.

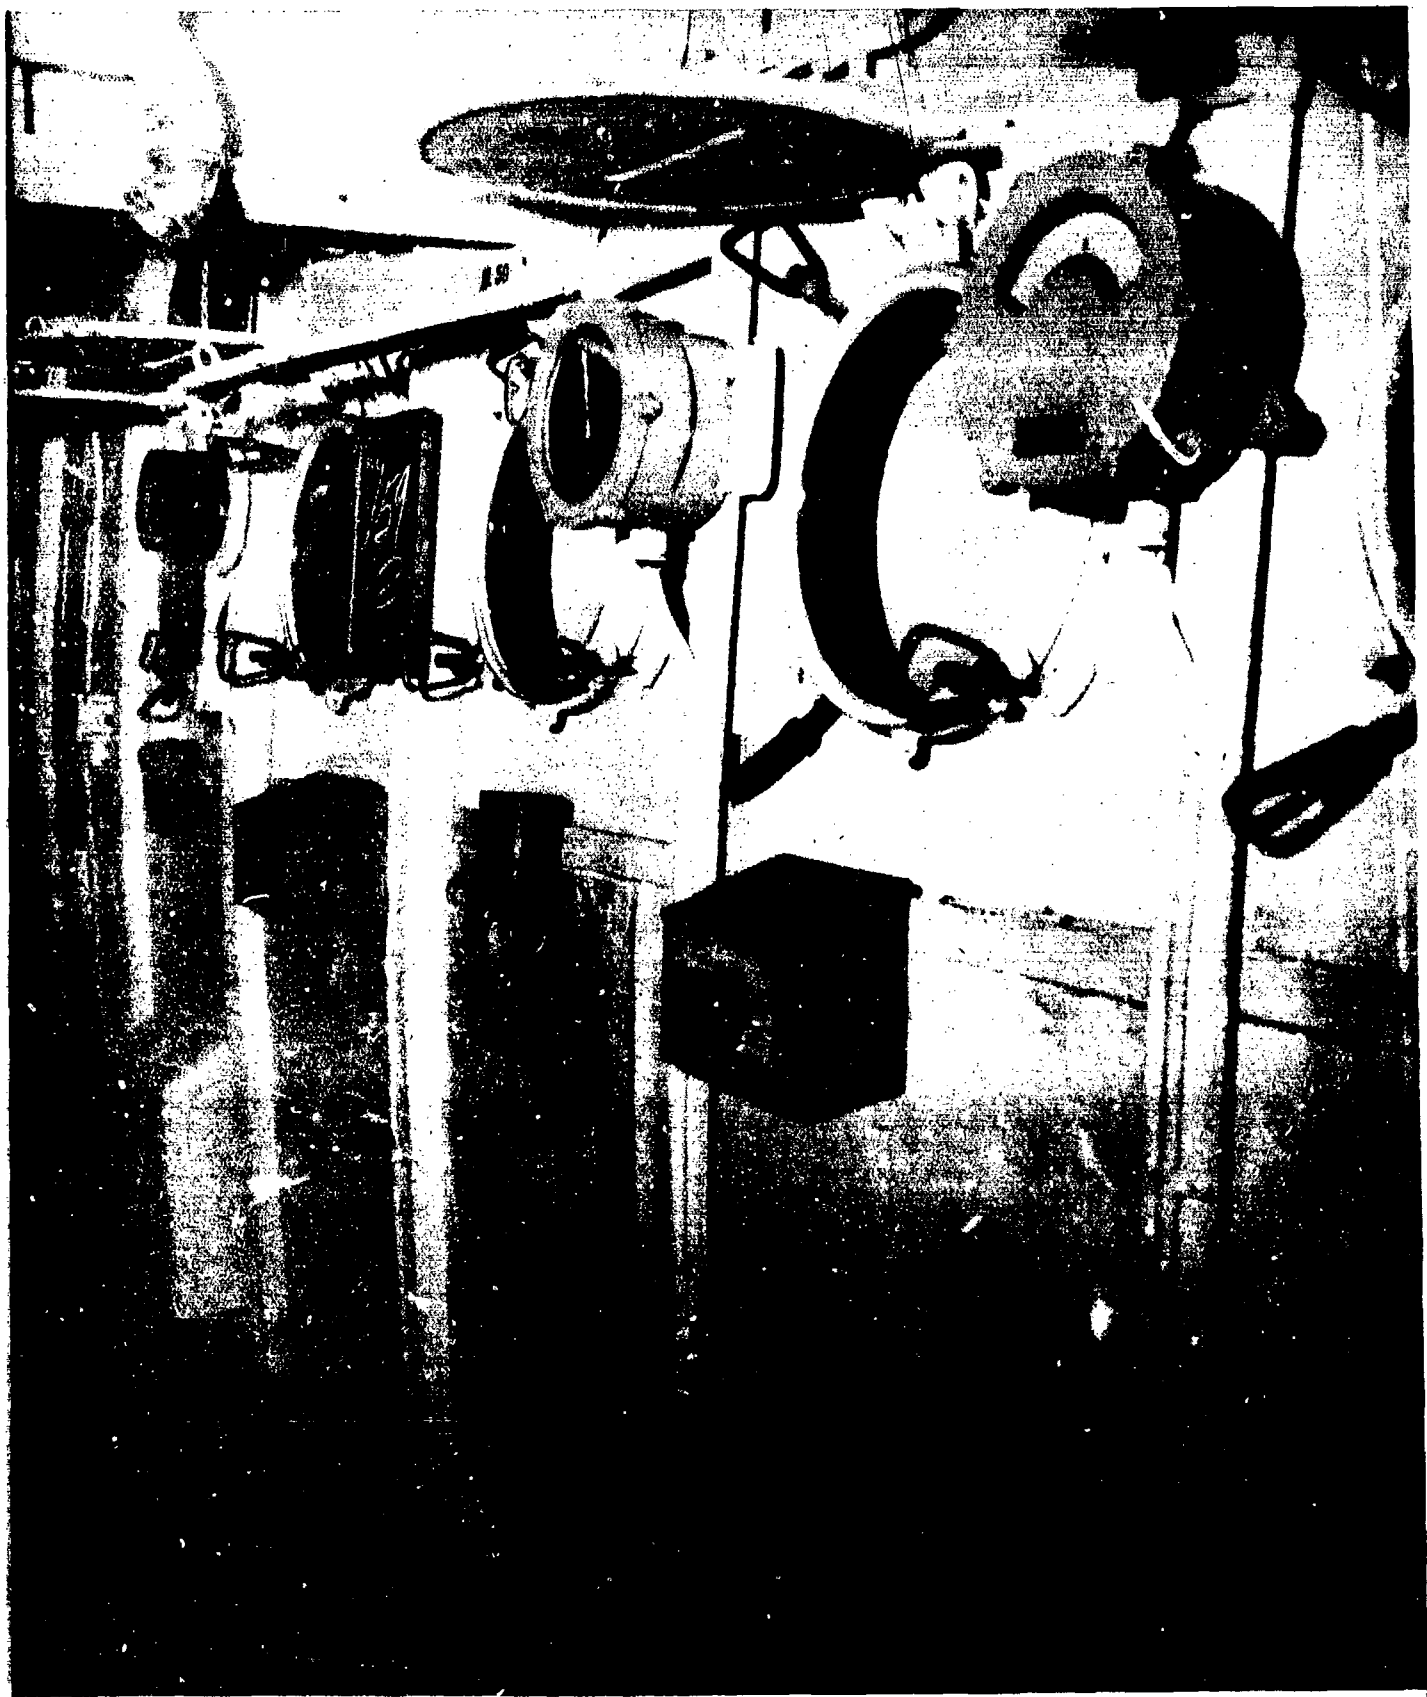
AA-CR-88-2104-7. Looking forward and to port in pilot house showing dishing of forward bulkhead.

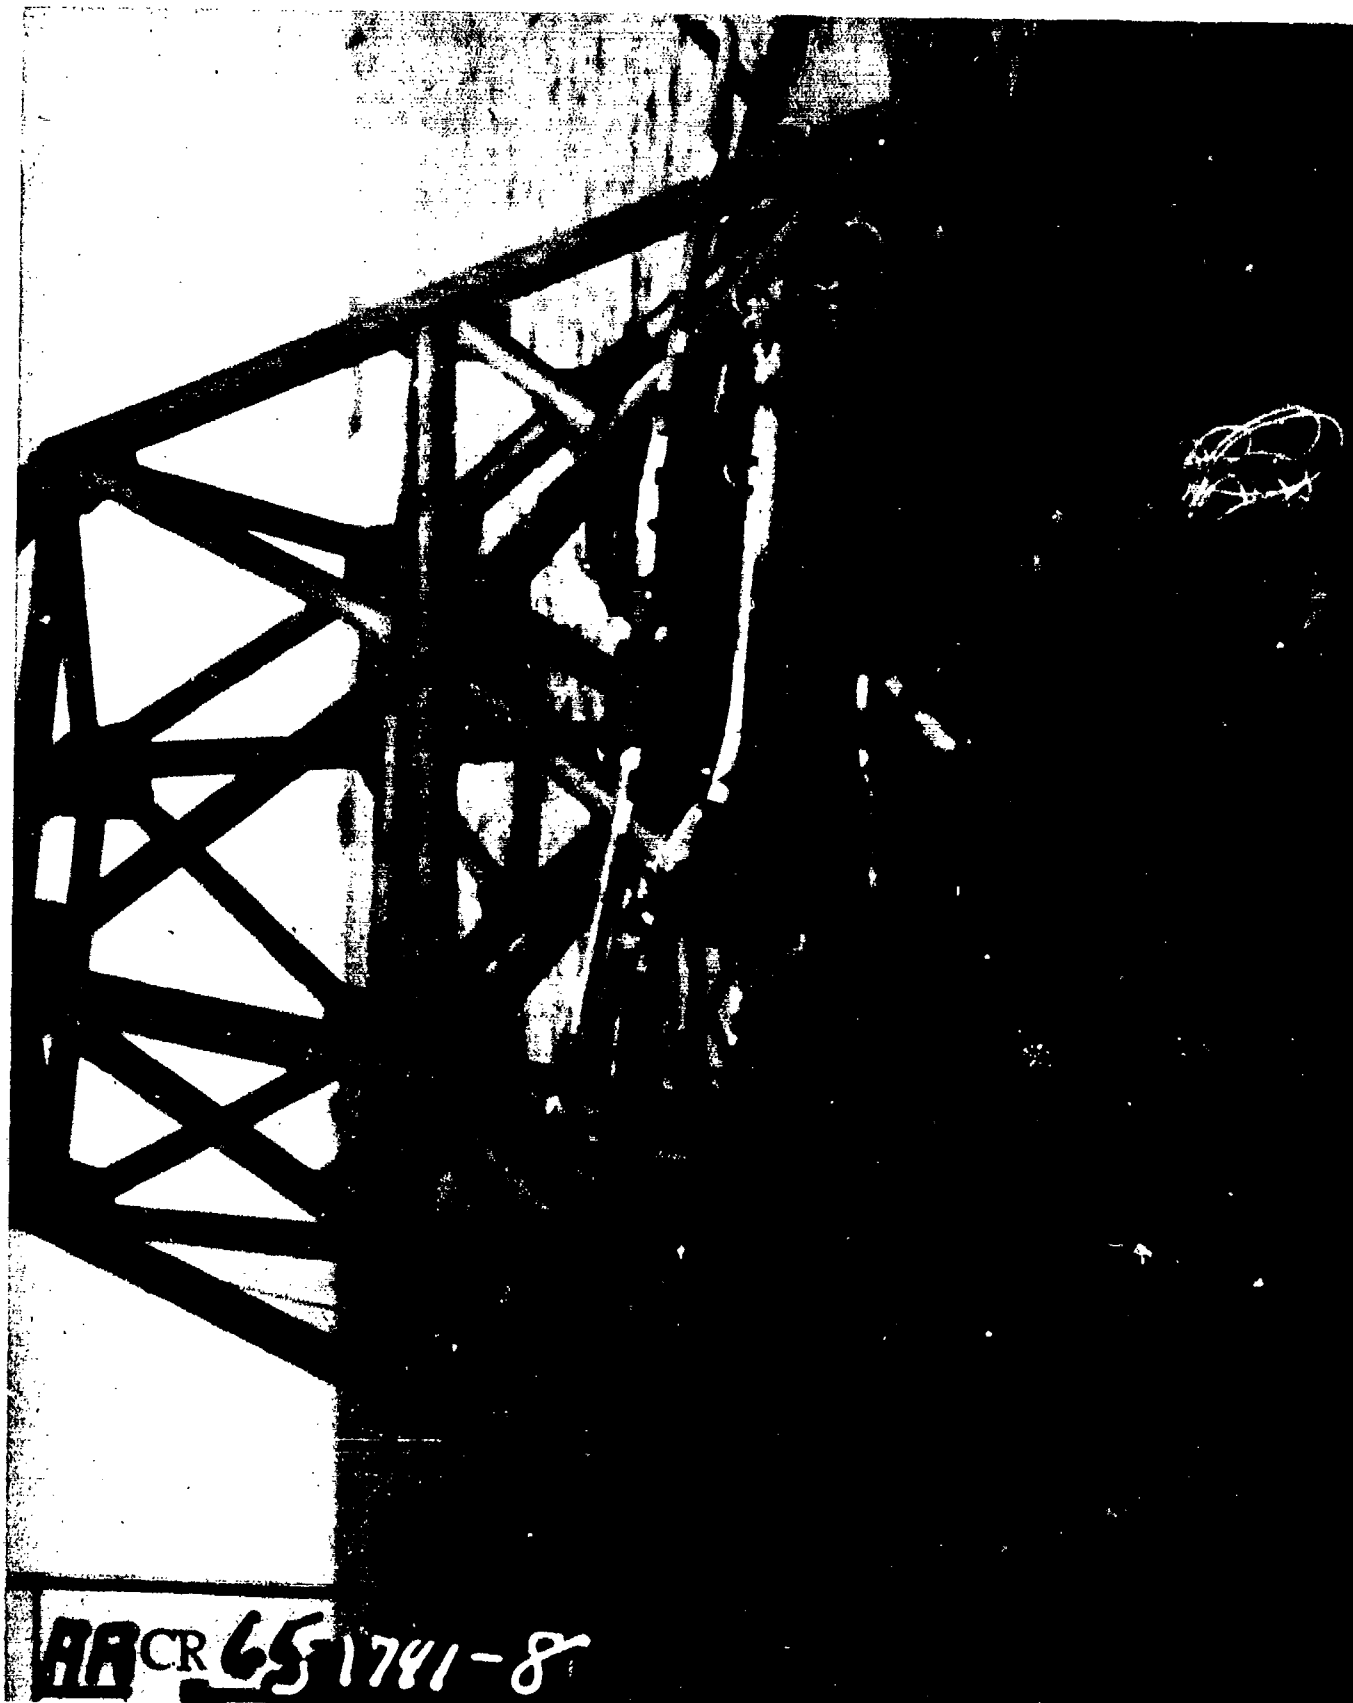
AA-CR-65-1741-8. Looking forward and to starboard, on starboard side of signal bridge, showing damage to railings, in way of starboard flagbag location. The flagbag was blown to the level below.

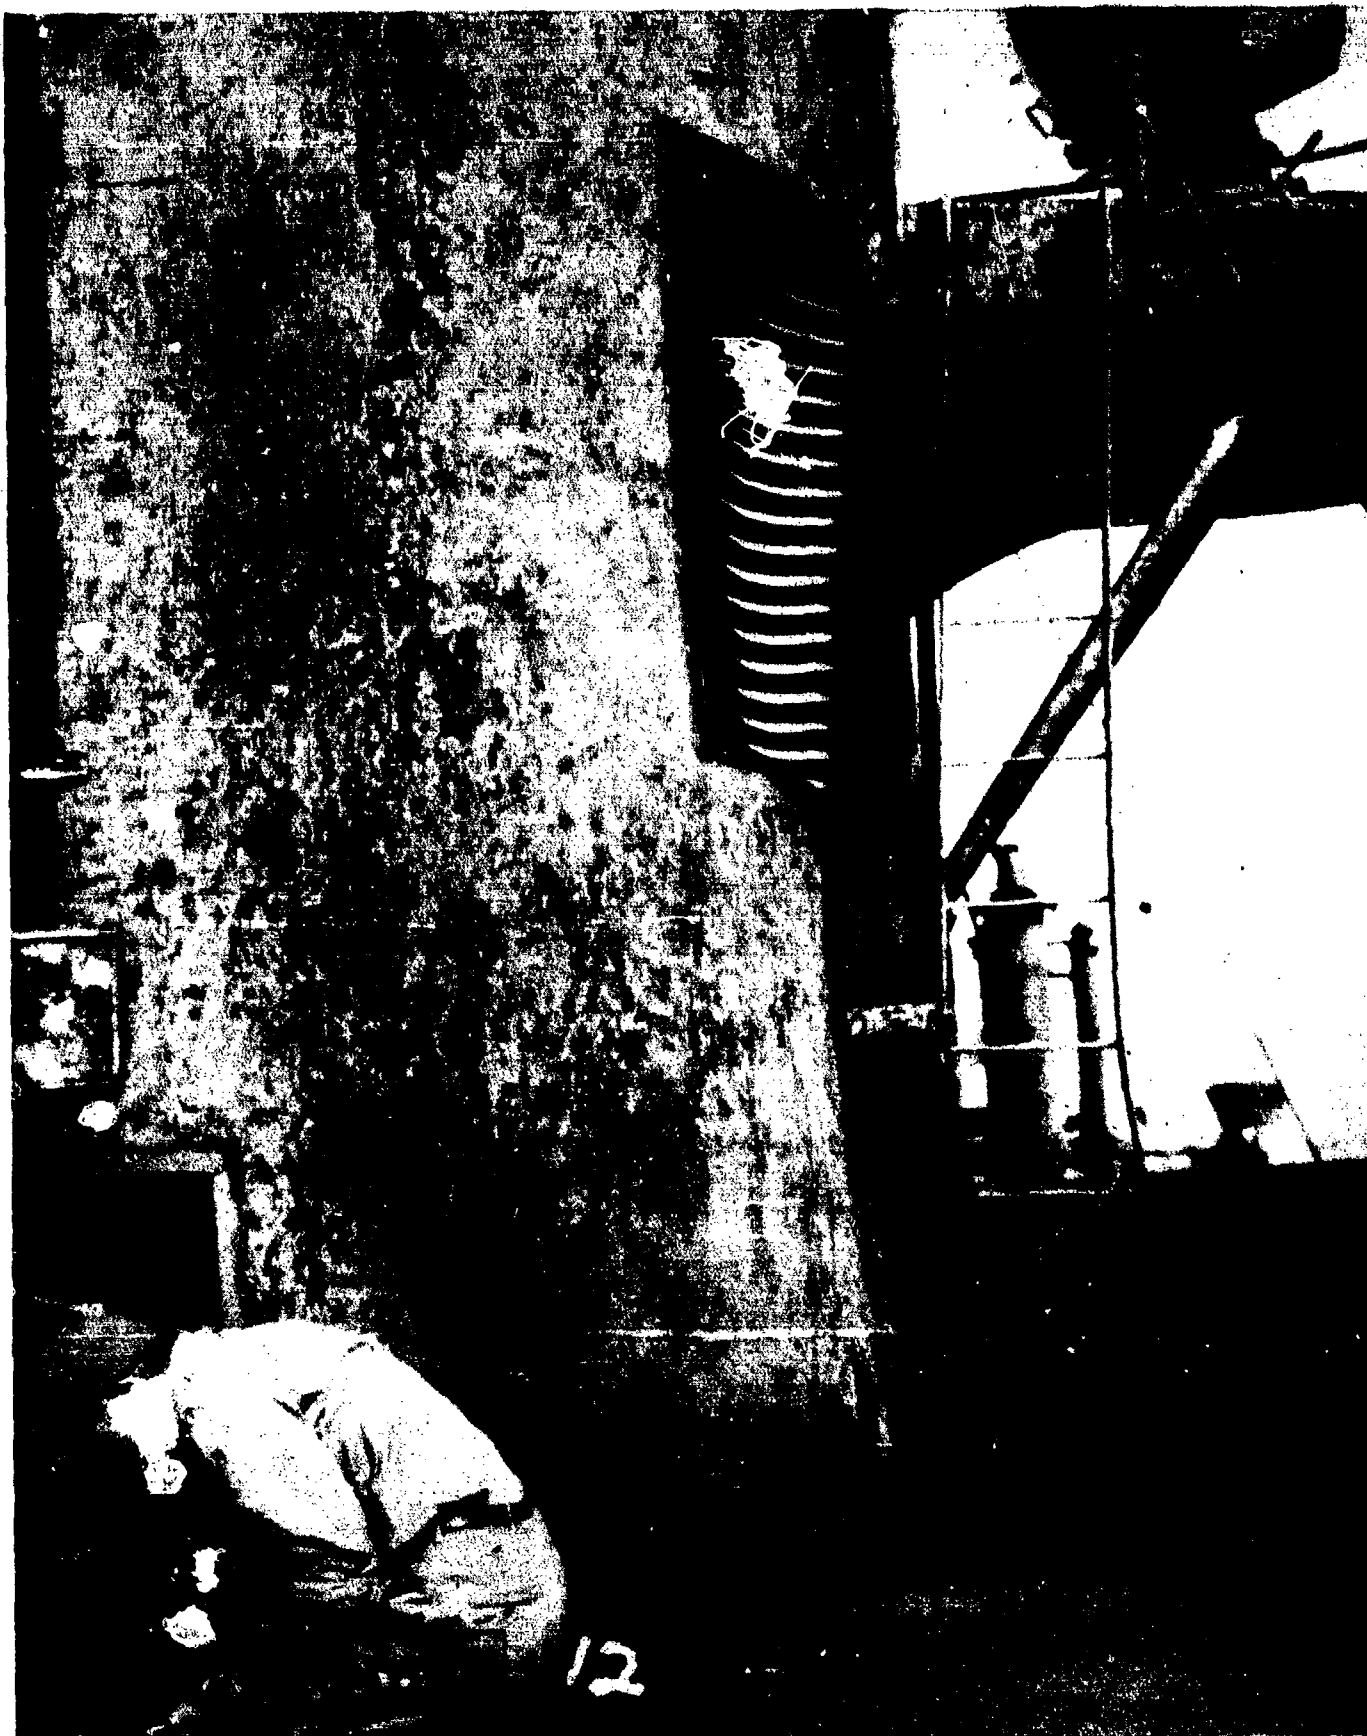
AA-CR-62-2168-12. Forward stack, port side, looking aft, note bowed ladder.

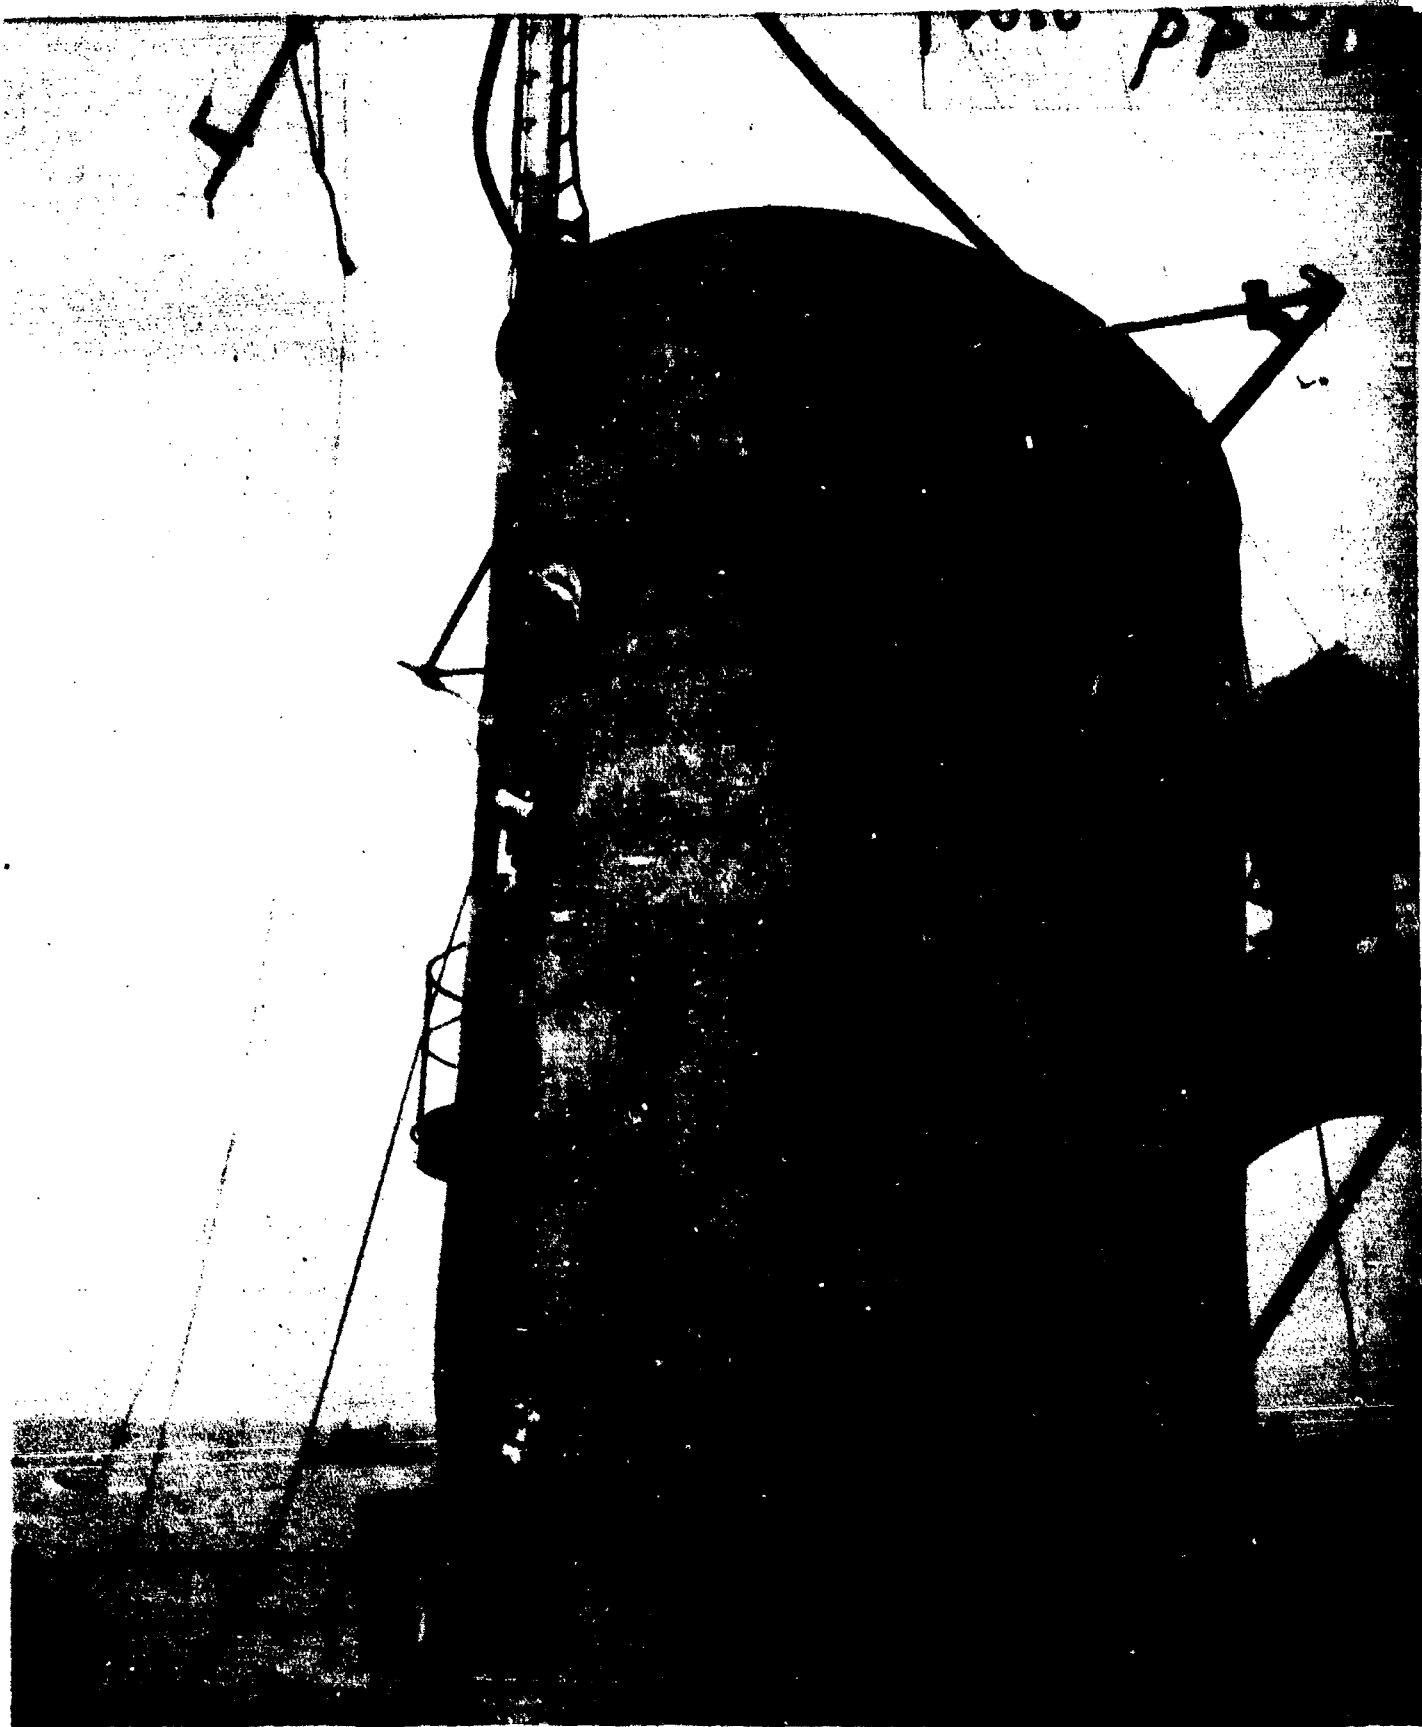
AA-CR-88-2104-8. Looking aft and to starboard, showing damage to forward stack, ladder and sun shields on ready service ammunition lockers.

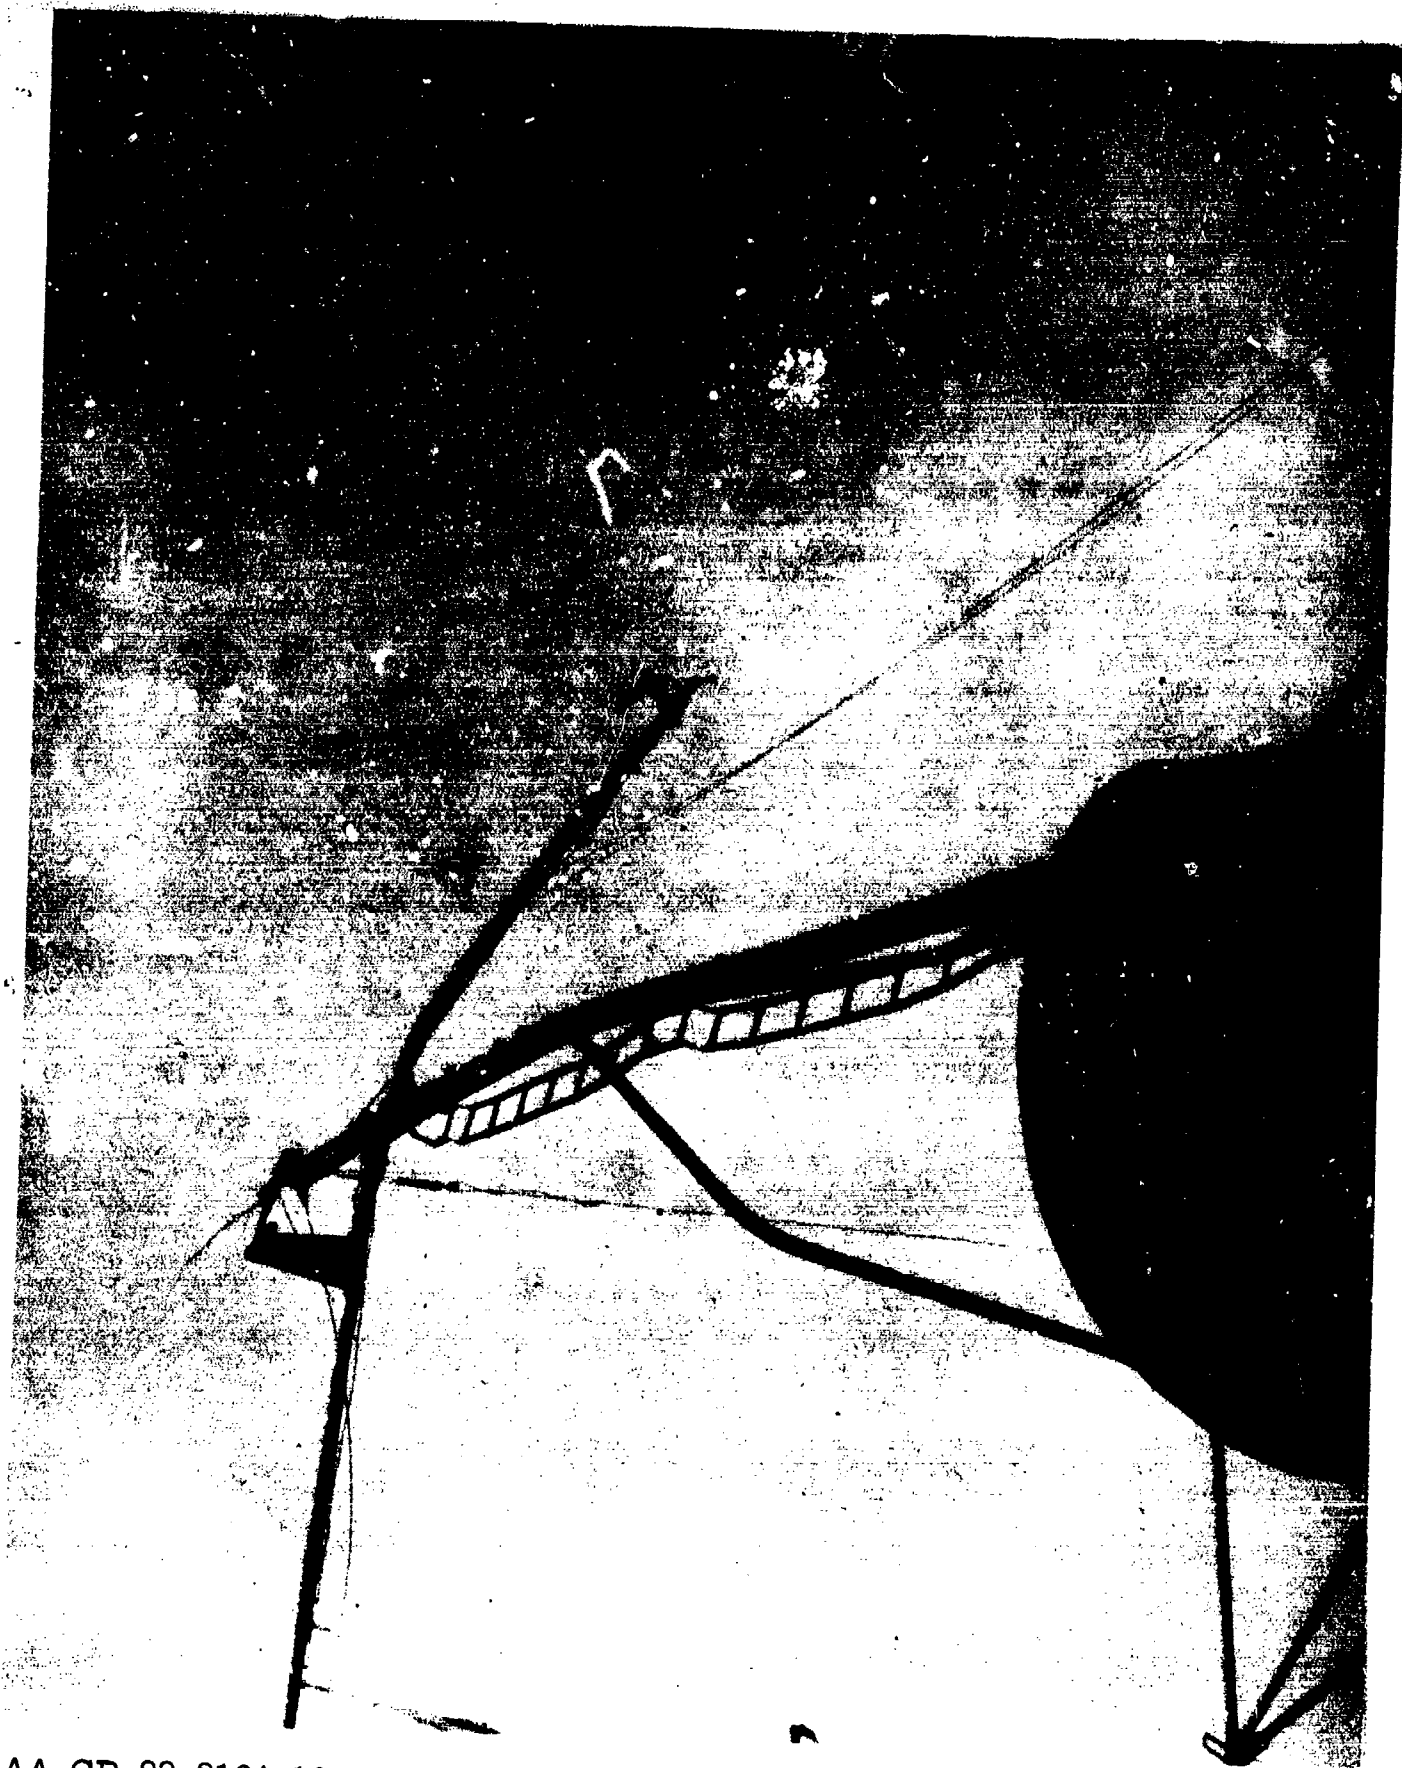
AA-CR-88-2104-10. Looking up, aft, and to port, showing damaged signal mast and yardarm at forward edge of forward stack.
